REPUBLIC OF KENYA
COUNTY GOVERNMENT OF NYAMIRA
NYAMIRA MUNICIPALITY

Citizen Forum on Improving Trading Spaces within Nyamira Municipality	
Venue	Kebirigo & Miruka Markets
Date	22 nd September 2023
Taking Proceedings	Paul Omanwa and Winnie Oseko
Time	10:30 AM

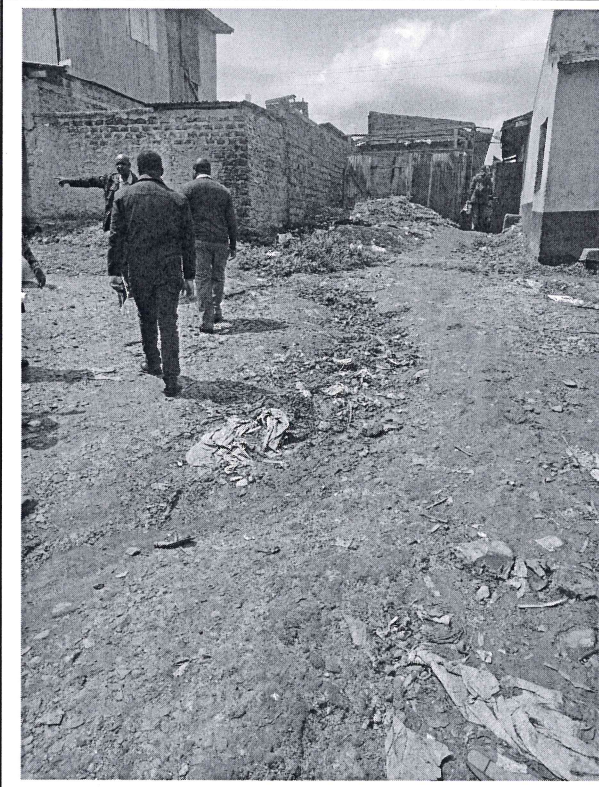
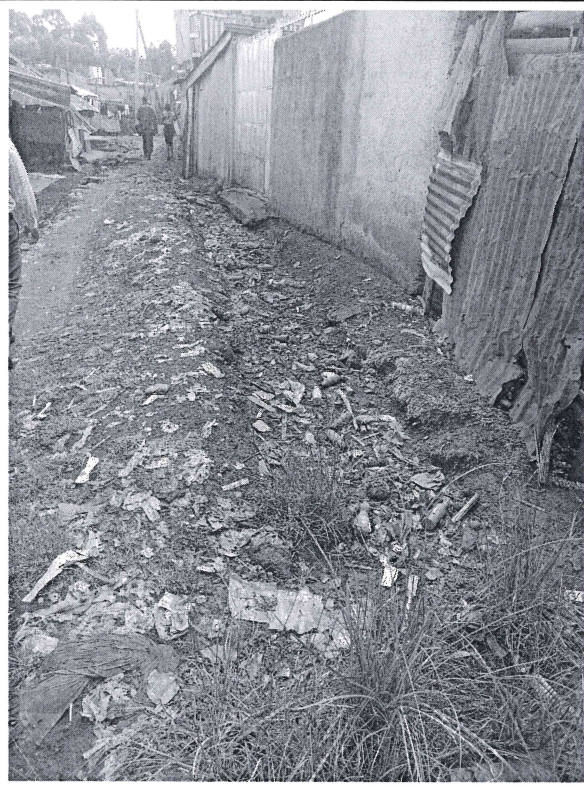
Collection Points- Five waste collection points exist with varying collection frequencies. However, points are poorly maintained, located near open drainage, posing health hazards. Lack of regulations against littering exacerbates the issue.

Indiscriminate dumping of solid waste and wastewater at Kebirigo Market

- V. Implementation of advanced solid waste collection processes and introduction of fines for careless dumping.
- VI. Construction and maintenance of drainages.
- VII. Provision of running water for various uses including ablution blocks.
- VIII. Expansion and renovation of toilet facilities.
- IX. Restoration of street lighting to extend trading hours.
- X. Opening and tarmacking of all backstreets for ease of navigation.
- XI. Call for diligent execution of duties by market leaders and county government employees to ensure market progress.

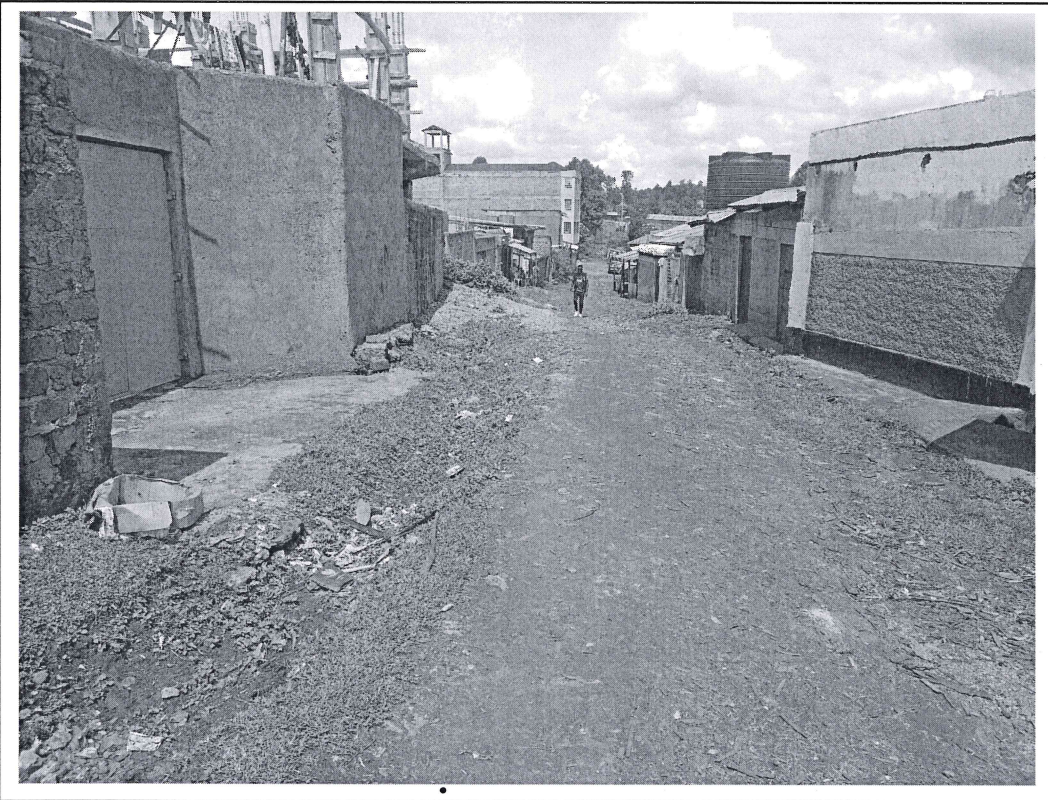
Traders report partial opening and poor condition of backstreets, especially during rainy seasons, impeding smooth navigation within the market. This observation was corroborated by the technical team.

Backstreet at Kebirigo Market

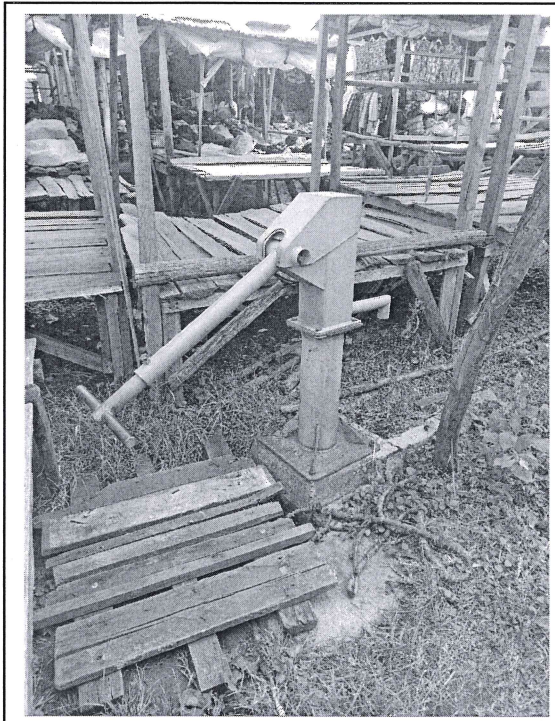
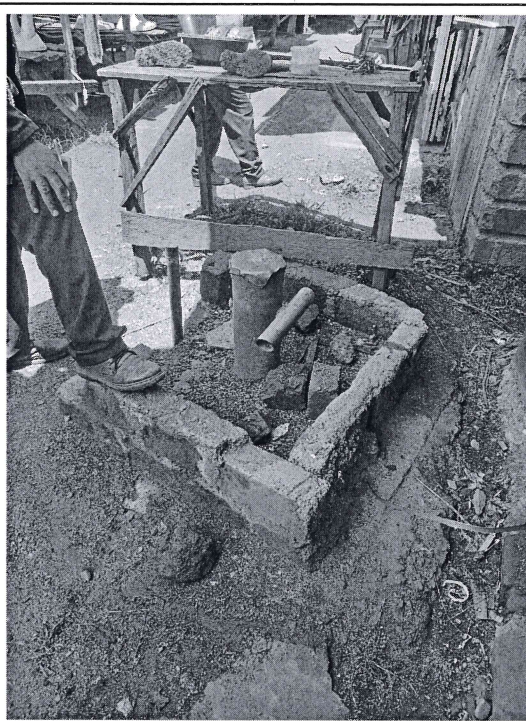
About 50% of traders rely on rainwater, 30% on river water, while the remainder uses water from wells and springs. The market possesses a non-functional borehole lacking a pump and a poorly covered well with a broken pumping pulley. Rectification of these issues could adequately supply water to traders and ablution blocks.

A borehole and Well at Kebirigo Market

Element	Current Status	Issue	Recommendation
Water	Reliance on rainwater; Has a borehole and well which are not functional.	Insufficient water supply; faulty infrastructure	<ul style="list-style-type: none"> - Connect piped water to the market. - Purchase of water pump for the borehole to be functional; properly cover the well and repair the pumping pulley.
Waste Collection	One collection point near an open storm water drainage.	Insufficient collection points; unregulated dumping	<ul style="list-style-type: none"> - Construct three additional dumping/garbage collection points.
Toilet	Two toilets present; lack of water and maintenance	Inadequate facilities; poor maintenance	<ul style="list-style-type: none"> - Reassign toilet maintenance to a dedicated individual. - Construct one additional toilet to accommodate peak demand.
Street Lighting	Present but non-functional	Lack of functionality	<ul style="list-style-type: none"> - Repair existing streetlights. - Install additional streetlights.

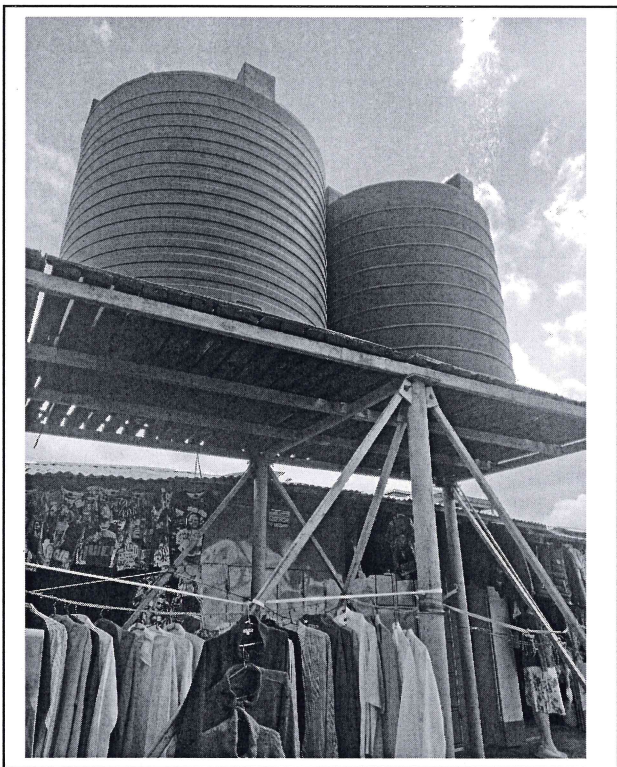
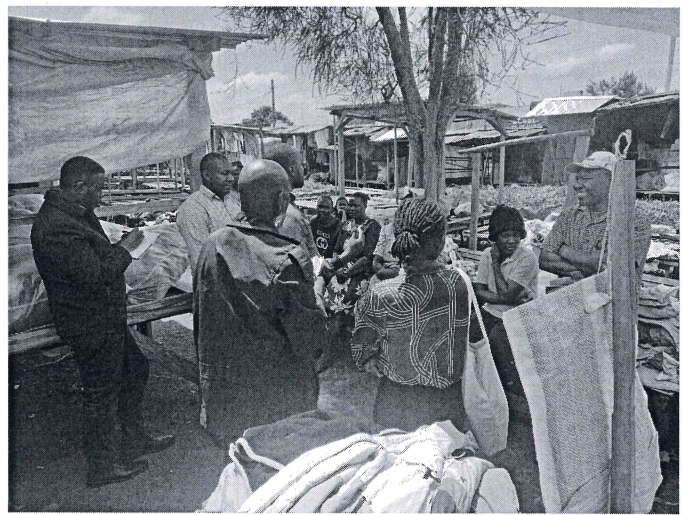
Inadequacy and Need for Renovation majority of the trader's express dissatisfaction with existing stalls, citing inadequacy and necessity for renovation. Consequently, temporary structures proliferate.

Water tanks and temporary market stalls at Kebirigo Market

Market Stalls	None	Lack of storage facilities	<ul style="list-style-type: none"> - Construct market stalls and storage facilities for traders' use.
Emergency Preparedness	Absence of fire assembly points and extinguishers	Lack of disaster preparedness	<ul style="list-style-type: none"> - Develop an evacuation plan. - Install fire assembly points and provide extinguishers.
